Arbor-Eco Consultancy

VISUAL TREE ASSESSMENT REPORT (VTA)

Arbor-Eco Consultancy was commissioned by the Clerk & RFO to Wickham & Knowle Parish Council, to undertake a ground level Visual Tree Assessment (VTA) and assess the health and safety condition of trees growing on land, as directed by the client, at Wickham Meadows, Wickham within the administrative boundary of Winchester City Council in the county of Hampshire.

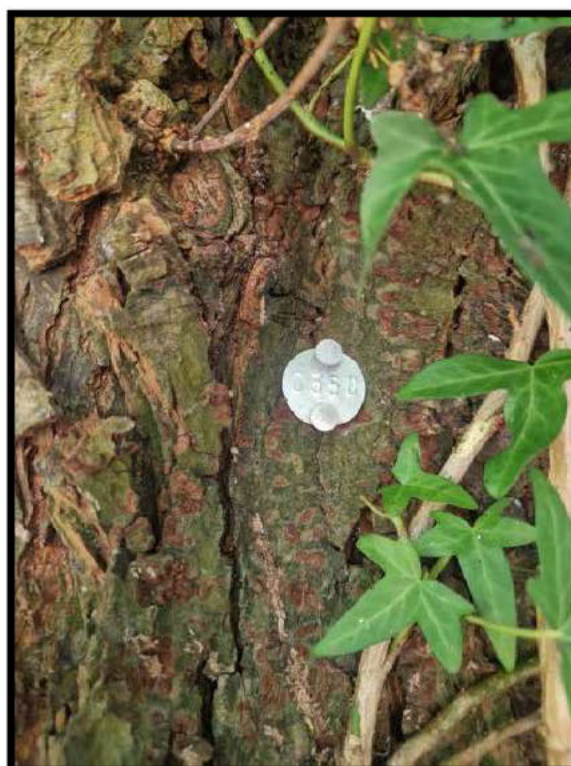
Plate 1: Identity disc fixed to stem.

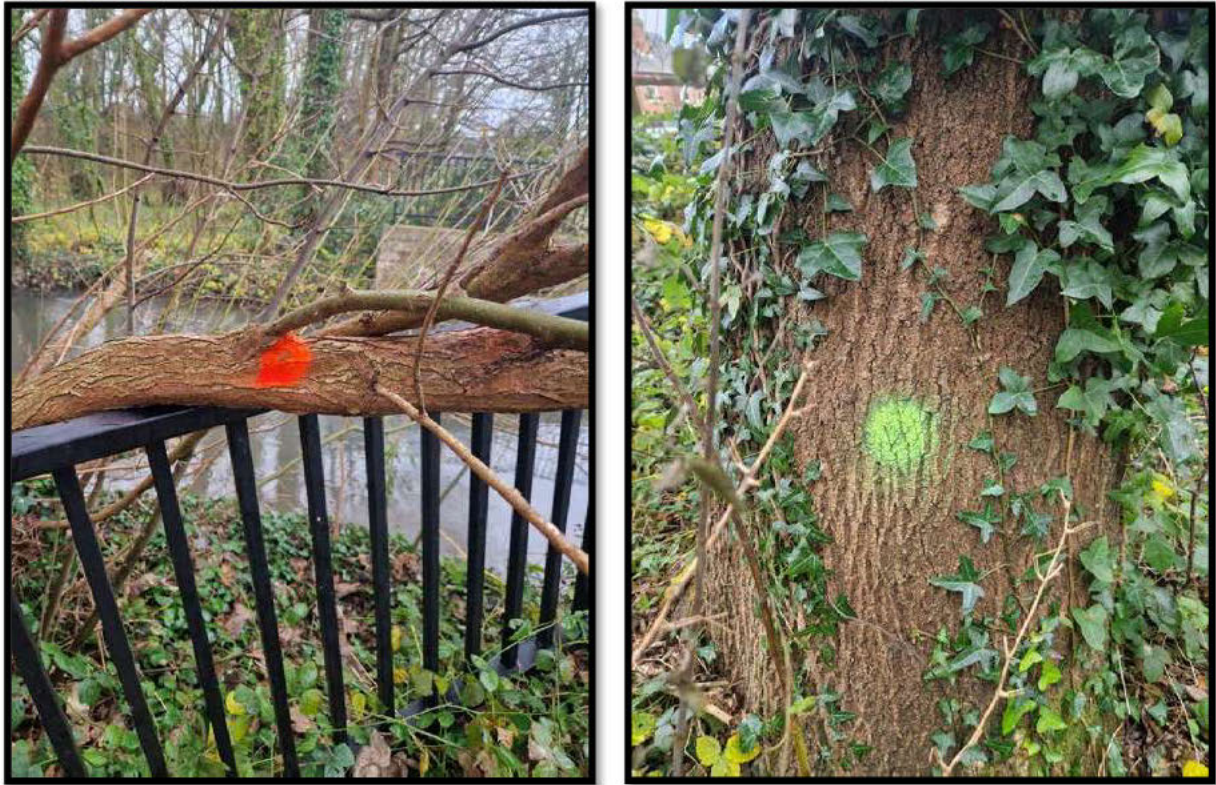
A red spray mark was applied to trees requiring felling. A yellow spray mark was provided to trees requiring remedial work (Plate 2). The paint is biodegradable and will remain for approximately 1 year before being washed off.

Plate 2: Paint markings.

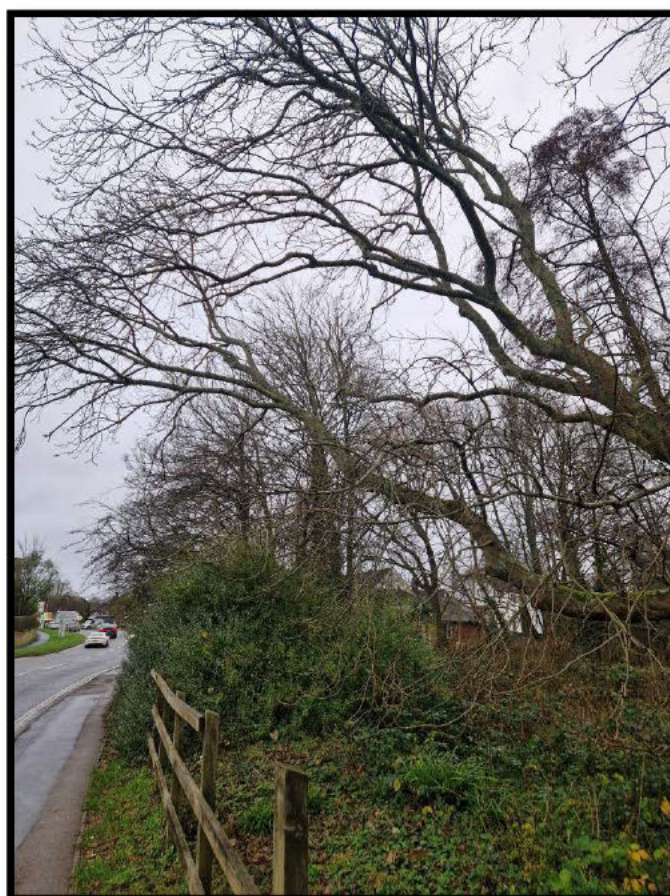
4.1.2 A number of trees were observed to be growing adjacent to the highway and footway. Trees and vegetation that overhang the highway should be crown-lifted to at least 5.2 m to allow safe passage of high sided vehicles as well as being cut back sufficiently from the edge of the carriageway to allow clearance for wing mirrors. Trees and vegetation that overhang footways and footpaths should be crown-lifted to at least 2.5 m and cut back to ensure the footpath/way is at least 1.2 m in width. This is to allow safe passage for all footpath/way users including wheelchairs, mobility scooters, etc.

Plate 3: Low hanging branches over Fareham Road.

These heights have been selected as an acceptable standard and any vegetation below this may be deemed to be an obstruction. Local Authorities may enforce Section 154 of the Highways Act (1980) which allows a local authority to serve notice upon the owner of the trees/vegetation informing them that they need to clear any obstructions safely.

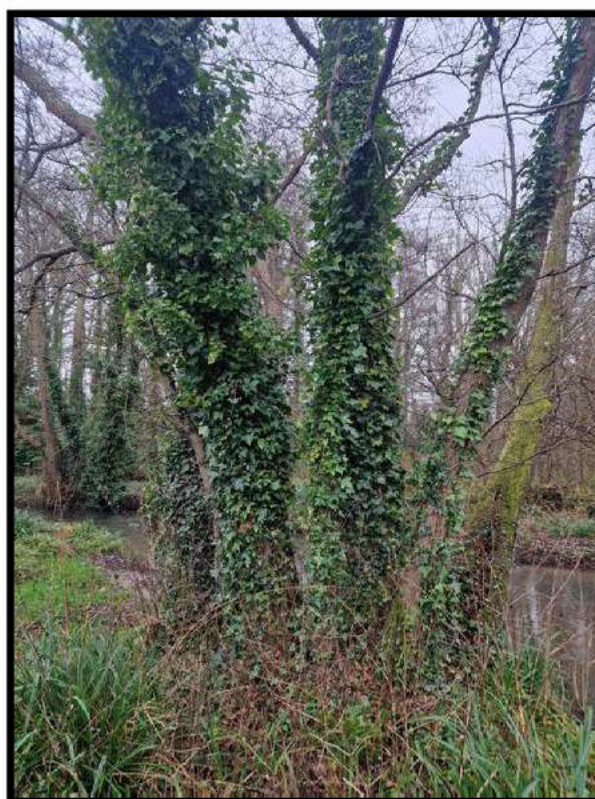
A number of the trees were recorded to have had ivy (*Hedera helix*) growing on the stem and in the crown. The wildlife benefits of ivy out-weigh its' removal however, where trees are growing in close proximity to a hazard (footpath or building for example) it is advisable to maintain a clear stem for survey and inspection access. Ivy does not directly harm a tree as it uses the tree stem to gain height in order to maximise photosynthetic opportunity. Once growing within a crown of a tree it can shade out the parent tree leaves causing dieback. In addition to this, the ivy creates an additional sail that catches the wind and the weight of this is not compensated for by the tree and it can cause branch failure. Ivy is a relatively simple plant to eradicate on tree. It can be done cutting a ring from the stem of the ivy plant leaving a gap between broken or cut parts of about 100 mm. These ivy rings will prevent water and nutrients from reaching the leaves and the leaves and stems will eventually fall from the tree from where they were attached. It is recommended that the mature trees are free from ivy to facilitate future inspections.

Plate 4: Tree shrouded due to ivy.

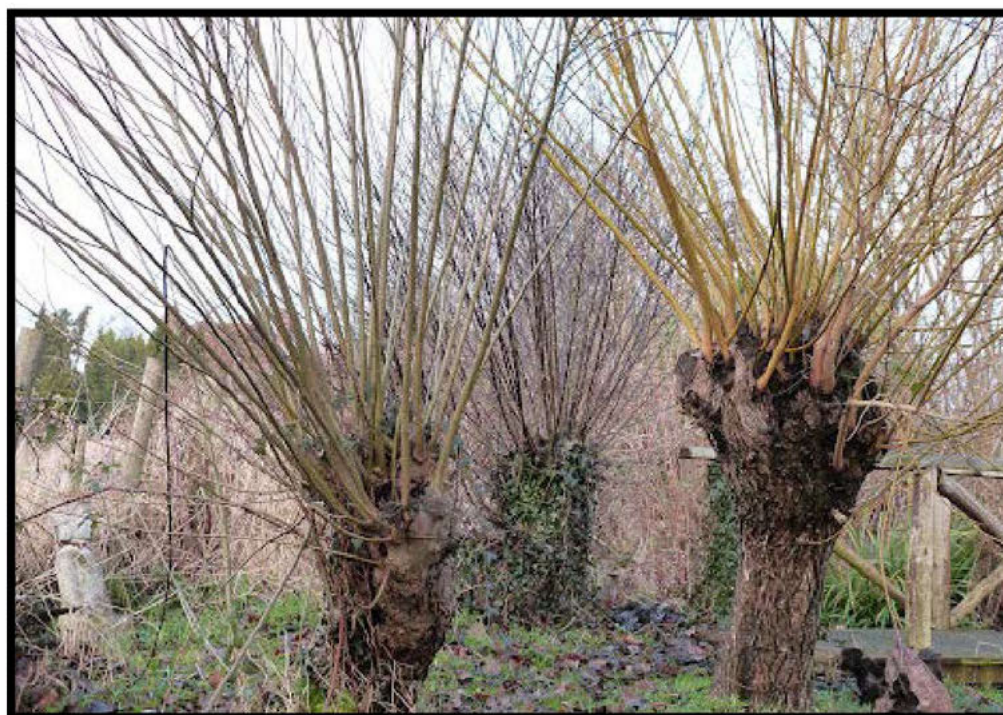
4.1.11 The waterlogged woodlands W1 and W2 have a good number of Goat Willow growing within them. This species of tree has a habit whereby the tree collapses as a propagation strategy. These trees can be high coppiced to promote regrowth and also to alleviate the sudden stem failure that may occur without good warning as did on the northern river bank near the substation.

Plate 5: High coppice of willow trees.

Carrying out the work is optional, however, it is ignored with some risk.
